COMMON BOND

INSIDE: Restoring Radiance: The St. Augustine Altar Heist and Revival | Conserving and Preserving Historic Sites | Restoring a Thriving Multigenerational Synagogue: How a Sacred Site Grant Supports an Historic New York Community | Hyde Park Mouldings: Work at the Central Synagogue Fire Restoration | Fire Prevention: Don't Get Burned

Common Bond is the technical journal of the Sacred Sites Program of the NY Landmarks Conservancy.

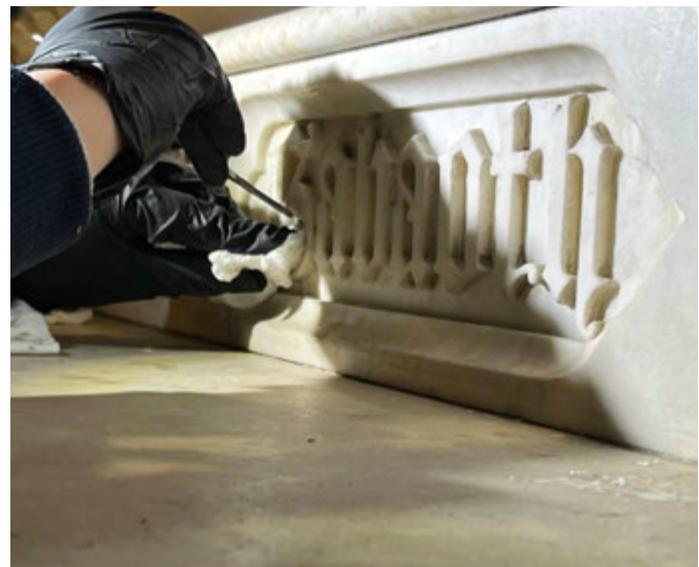
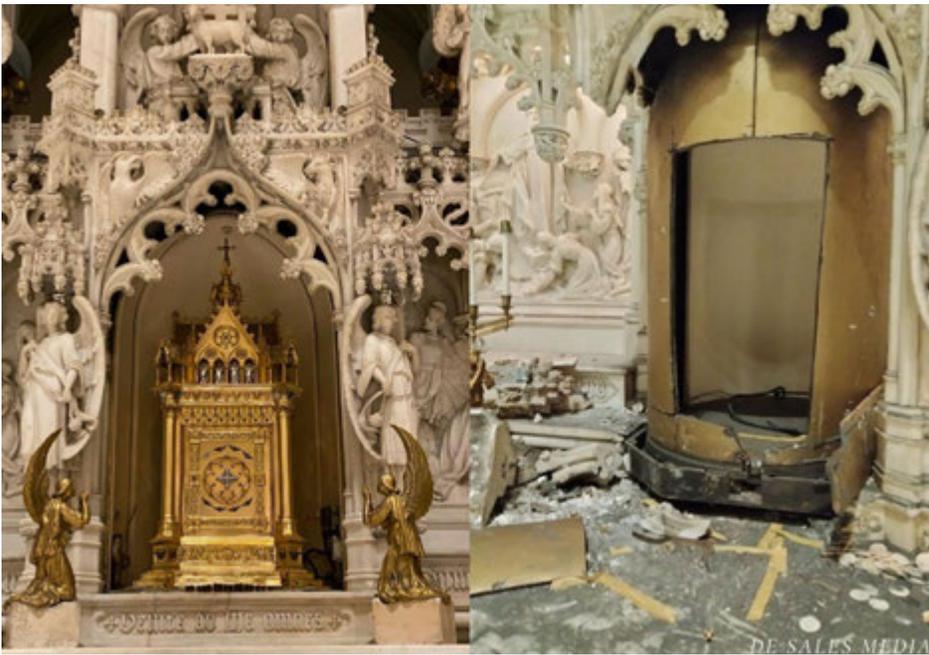
EverGreene began by carefully removing the compromised safe, which had been integral to the altar's construction. This involved precision cutting and rigging to prevent further damage to the surrounding stonework. Small fragments of the stolen tabernacle including pieces of gold and precious stones were recovered during the safe's removal and returned to the church.

Conservators used an arsenal of tools to realign and repair the altar including epoxy, structural pins, and custom fills, resetting displaced marble elements and reinforcing fractured areas, including a broken column and detached finials. Cleaning the reredos used a combination of dry and wet methods to target years of soot, wax, and staining, reviving its luminous stone surfaces and intricate detailing.

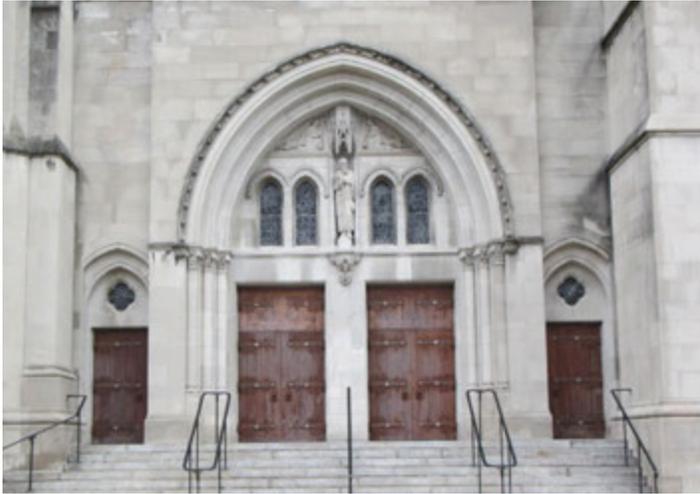
ranging from churches to libraries, universities, and major estates around the country. At Riverside, the wrought iron hardware was corroding and the coating put on the hardware and doors was failing. Senior Conservator, Tania Alam, was tasked with understanding why the failure occurred and how to repair the doors.

Eight of the doors dated to 1930, while the rest were from 1959. The wrought iron metal of 1959 was different than the 1930s metal and had more

corrosion. The doors were found to be in fair to poor condition with major deterioration conditions including the corrosion of cast iron hardware, hazing, failure of the protective coating on wood and metal hardware, and wood deterioration on the lower parts of doors on the south and east elevations. Samples of the failing finish coat were analyzed and found to be a modern acrylic resin varnish. The primary cause of deterioration was determined to be the failure of the clear finish coat applied to both wood and iron hardware on all the doors.

It was discovered that the original patination had been removed when the doors were taken offsite and refinished. Repatinating metals is typically done with chemicals and heat; however, it is not feasible to repatinate hardware when installed on wood doors. As Samuel Yellen Metalworkers is still in existence, JBC consulted with Yellen's granddaughter, Clare Yellin, about possible treatments. She recommended painting the hardware to protect it.

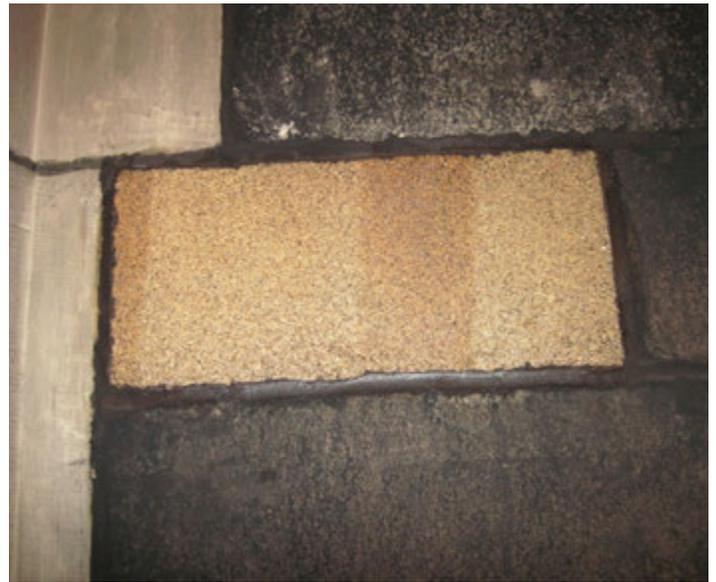
“The tile was heavily soiled from ninety-five years of use of charcoal-wax candles and incense. One of the challenges was to clean a very porous material without damaging it; therefore, a cleaning test had to be performed in an out of the way location,” Jablonski explained.

The cleaning tests revealed a much lighter interior as the Rumford Tile appeared to be a magnet for soiling, particularly from candle smoke and dirt that had accumulated with age. Testing allowed the Church to approve an acceptable level of clean and allowed the contractor to accurately bid the cleaning without guesswork as to products to use.

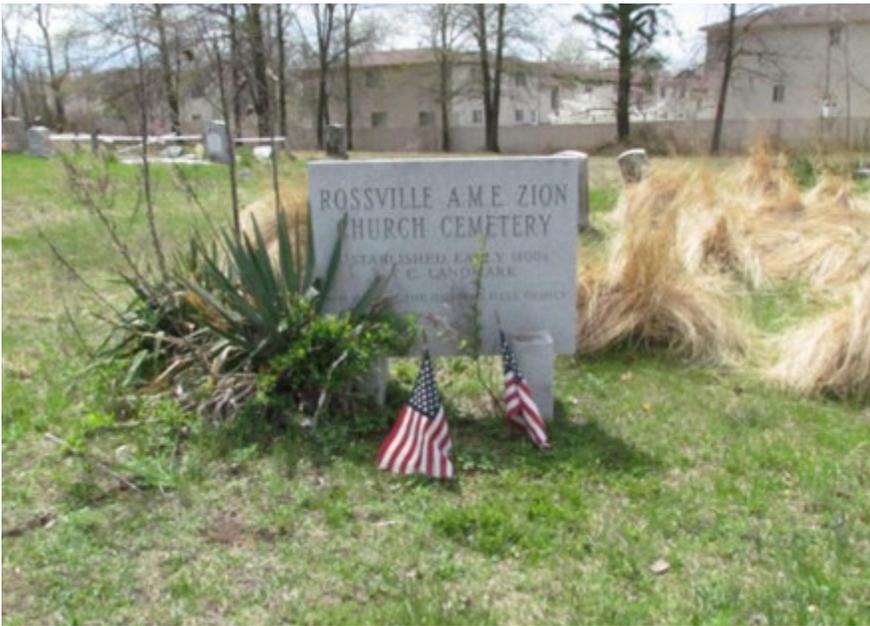
JBC teamed with Horsley Archaeological Prospection, LLC, to use ground-penetrating radar, (GPR), to search for unmarked graves. GPR identified four hundred eighty-one probable and

ninety-five possible burials.

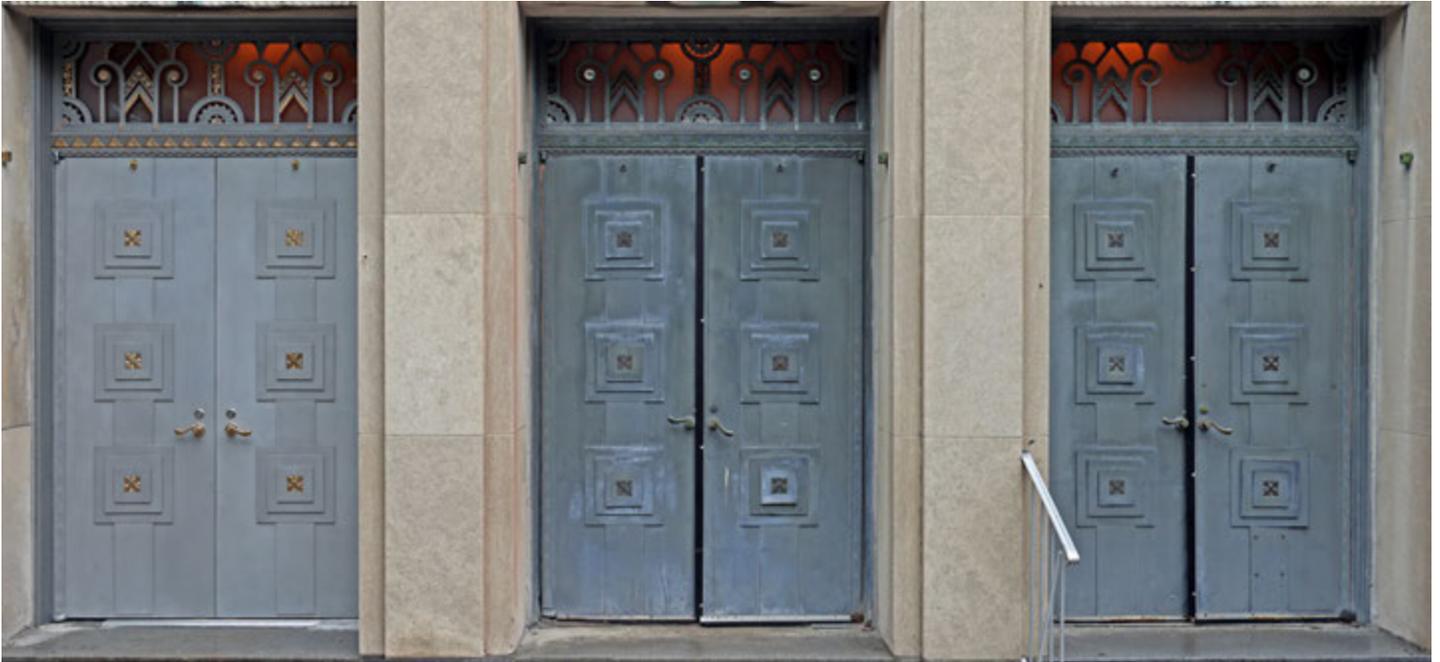
The far-left of three aluminum double doors, featuring cast aluminum and bronze decorative elements, has been restored and installed (April 2025).

With the help of a **NYLC Sacred Sites Grant**, the Hebrew Tabernacle could follow through with a true restoration of its iconic double doors, making them accessible to the public. Acheson Doyle Partners Architects (ADP) completed an initial feasibility study and proceeded with salvaging the existing ornamentation, recasting aluminum and bronze decorative elements to match the historic condition of the doors, and reusing the original bronze lever handles on new code-compliant door hardware. ADP engaged Shape Metalworks to manufacture and install the Hebrew Tabernacle Congregation's first set of artisan-crafted replacement doors that meticulously honors their spectacular aluminum materiality and bronze ornamentation.

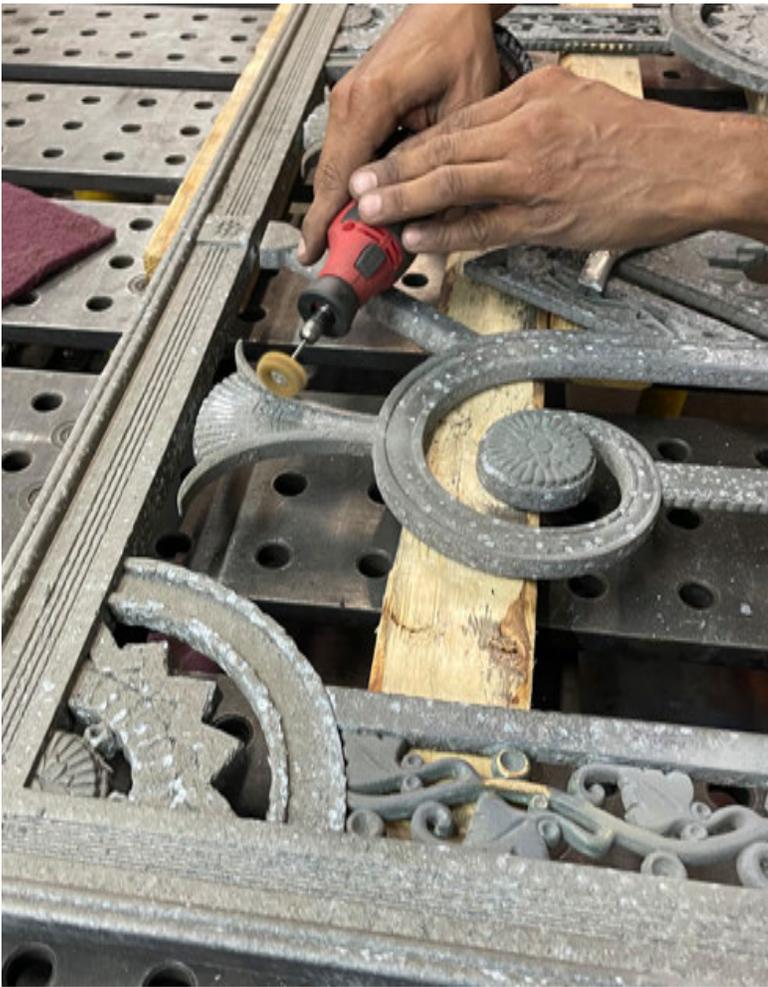
Manufacturing and installation of first set of artisan-crafted replacement doors completed by Shape Metalworks

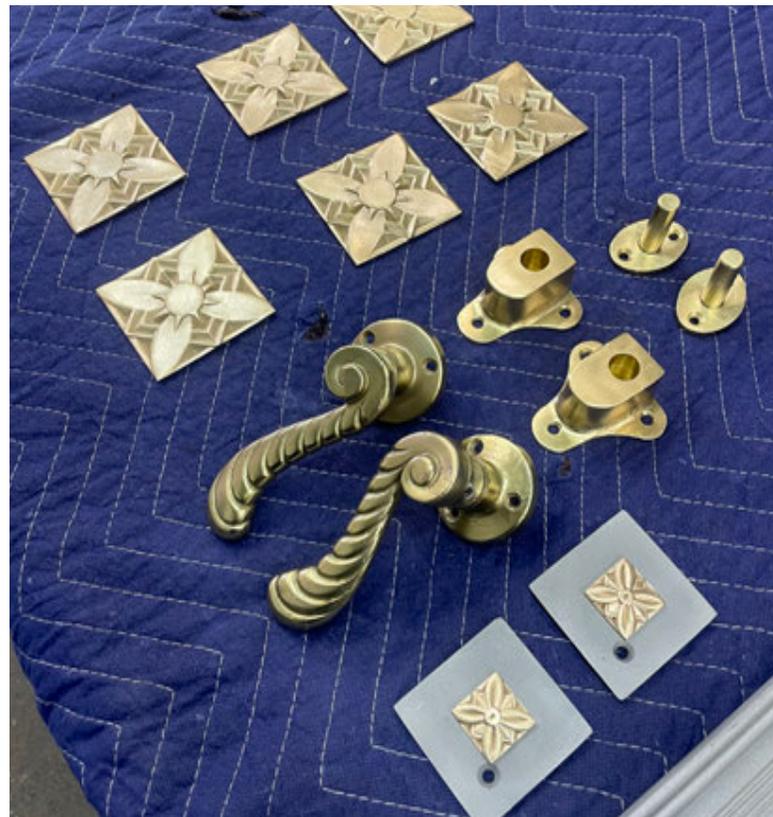
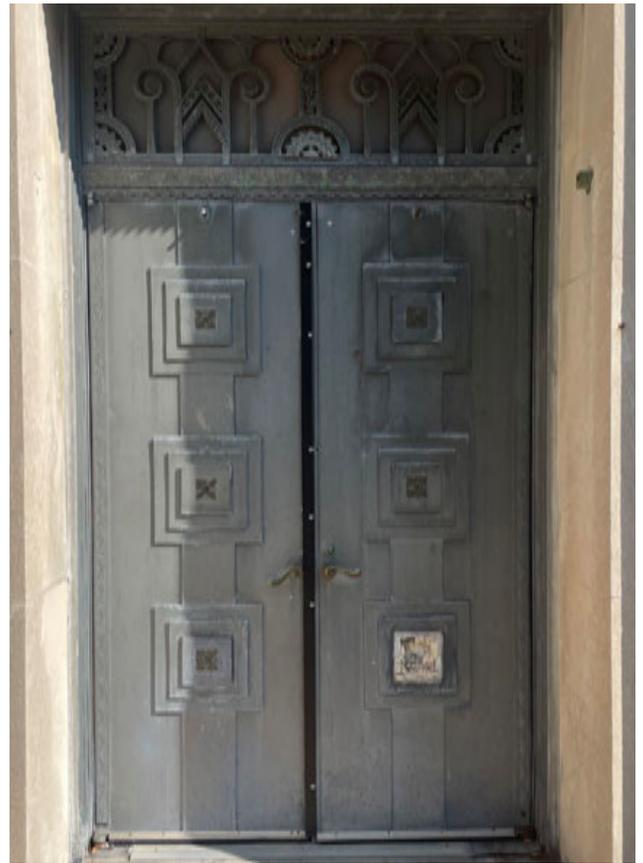
Initial condition of doors.

Maintaining a building of this caliber is a challenge for many nonprofit institutions. As the Hebrew Tabernacle building has aged, it faces deterioration, deferred maintenance and accessibility challenges. Its badly oxidized aluminum doors no longer close properly, and the partially stepped entryways original to the building on a sloped street have outgrown a multigenerational congregation with an increasing need for accessibility.

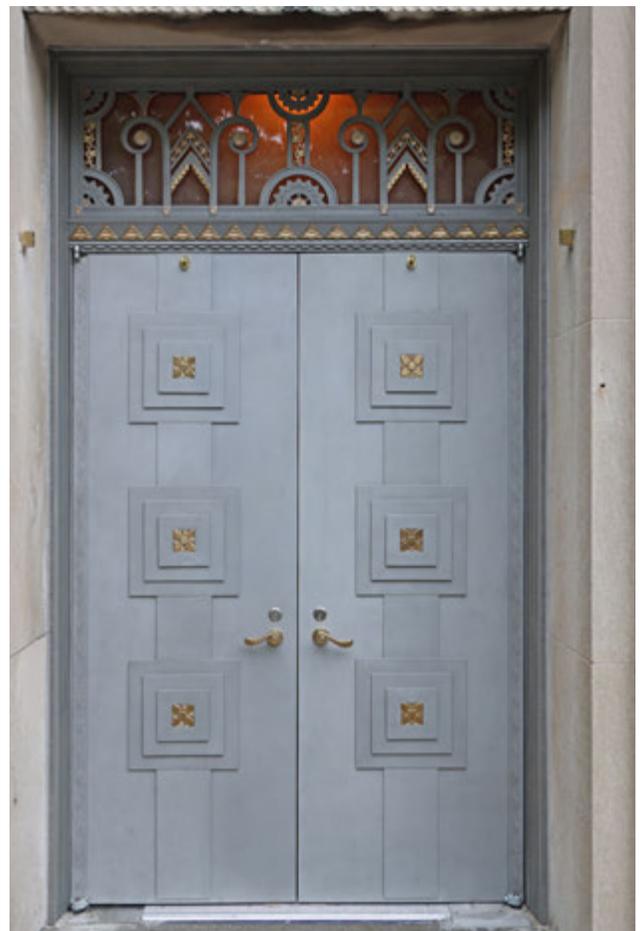
Restored condition of doors.

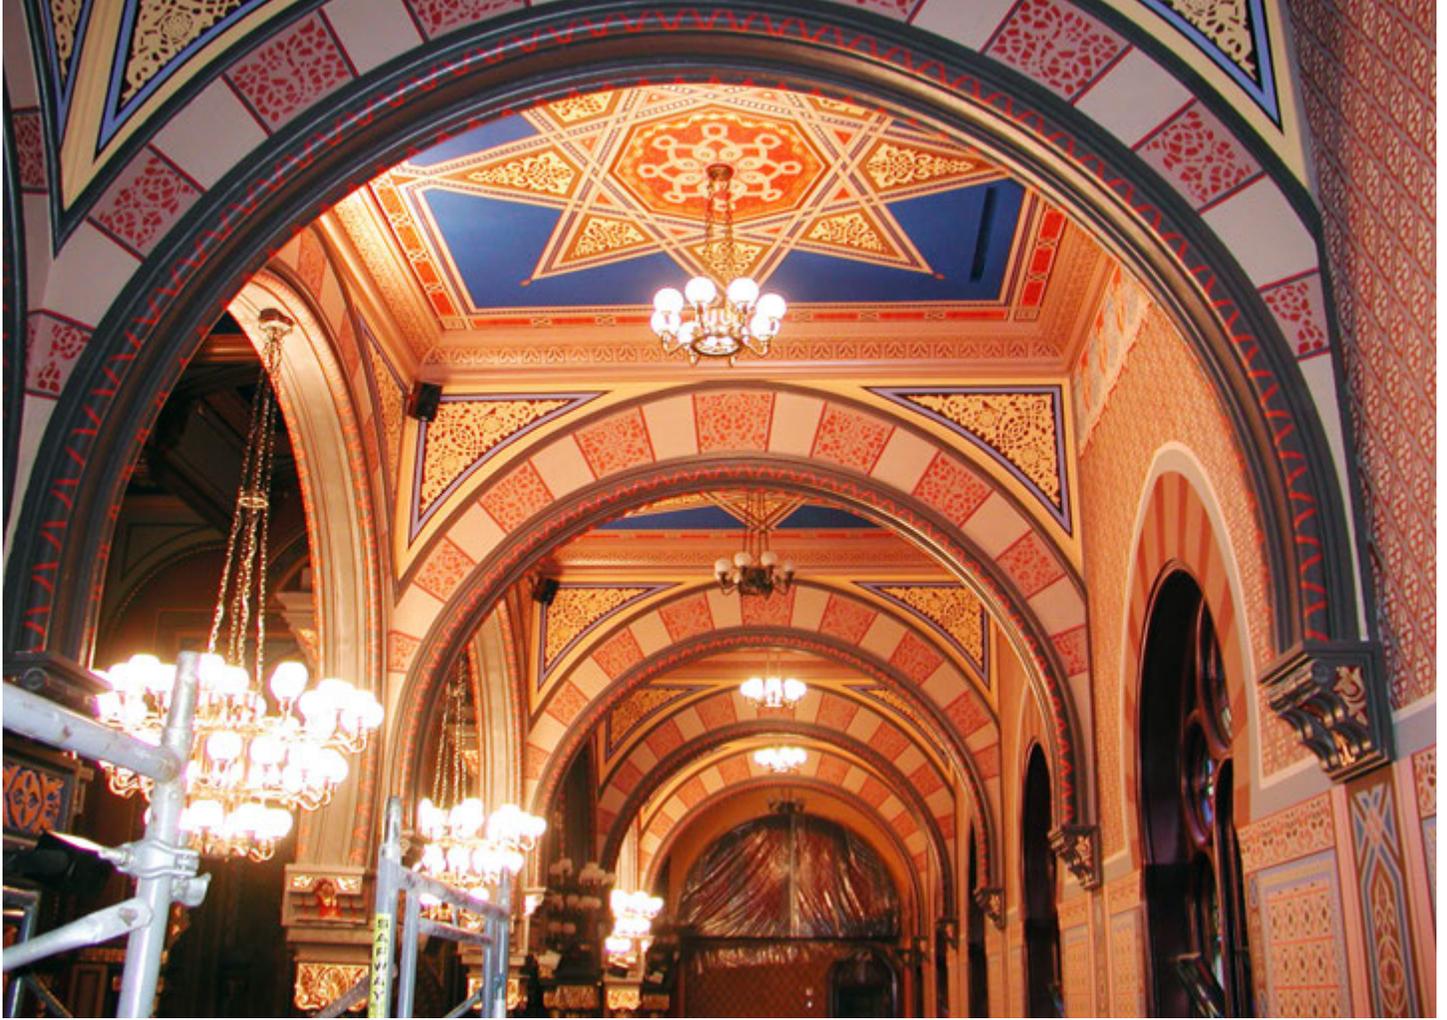
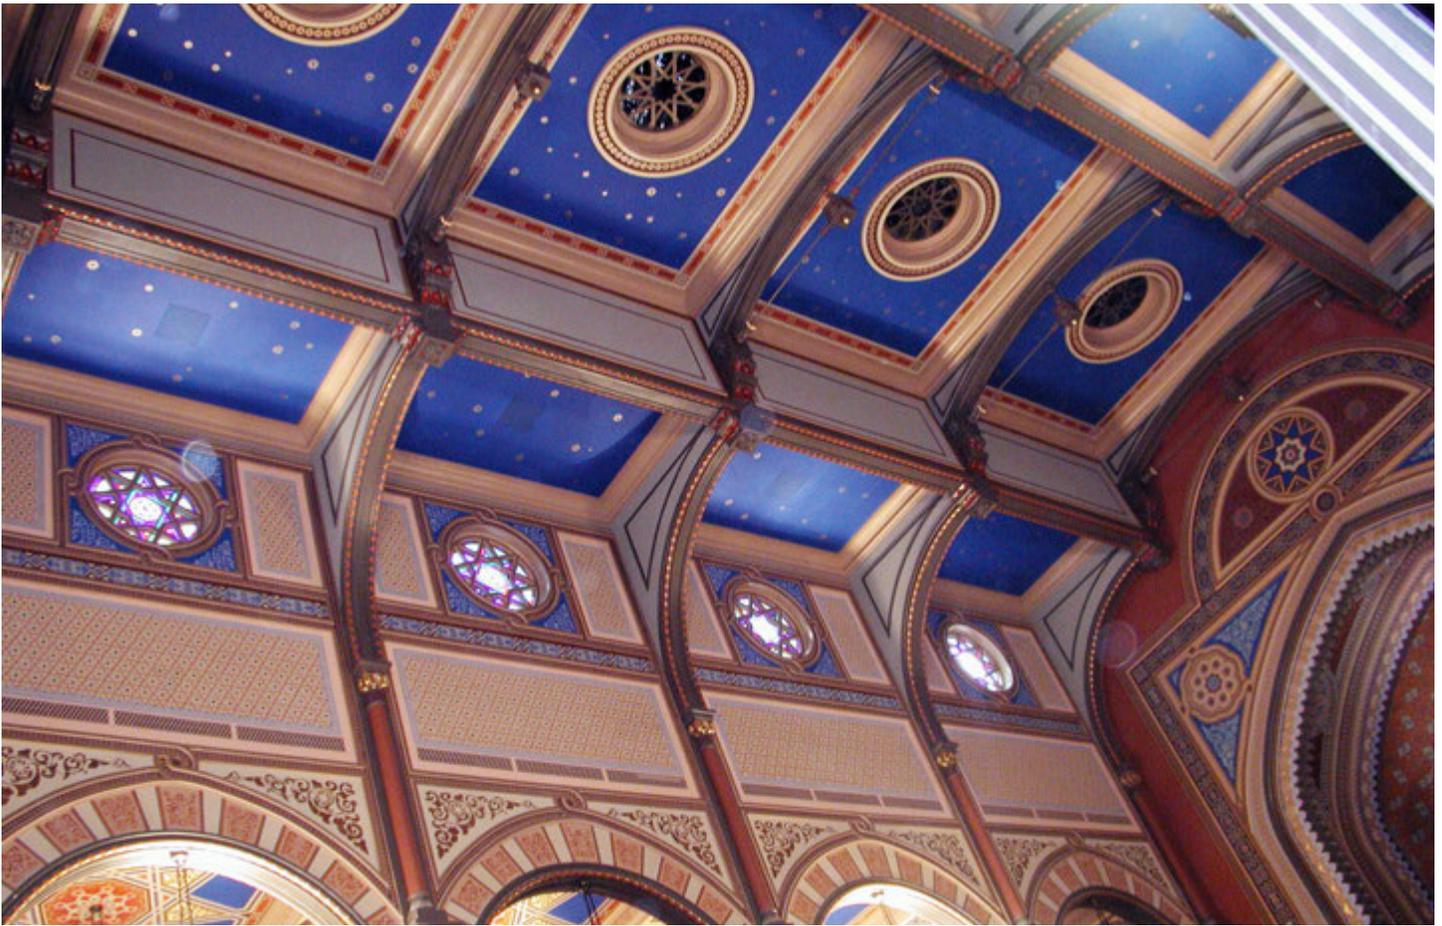
with painstaking accuracy. Working from archival photographs, fragments of surviving ornament, and historical research, the craftsmen at Hyde Park Mouldings recreated the sanctuary's lavish medallions, arabesques, and filigree with precision and reverence. Each element was sculpted, cast, and installed to align seamlessly with the synagogue's architectural narrative, restoring the space to its original splendor while honoring its storied past.

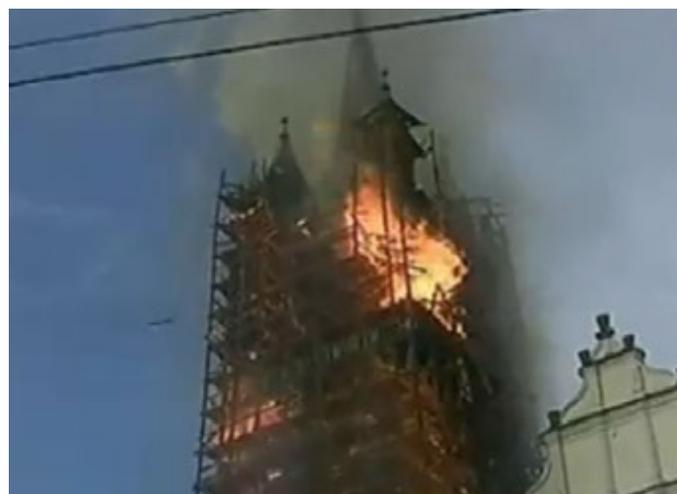
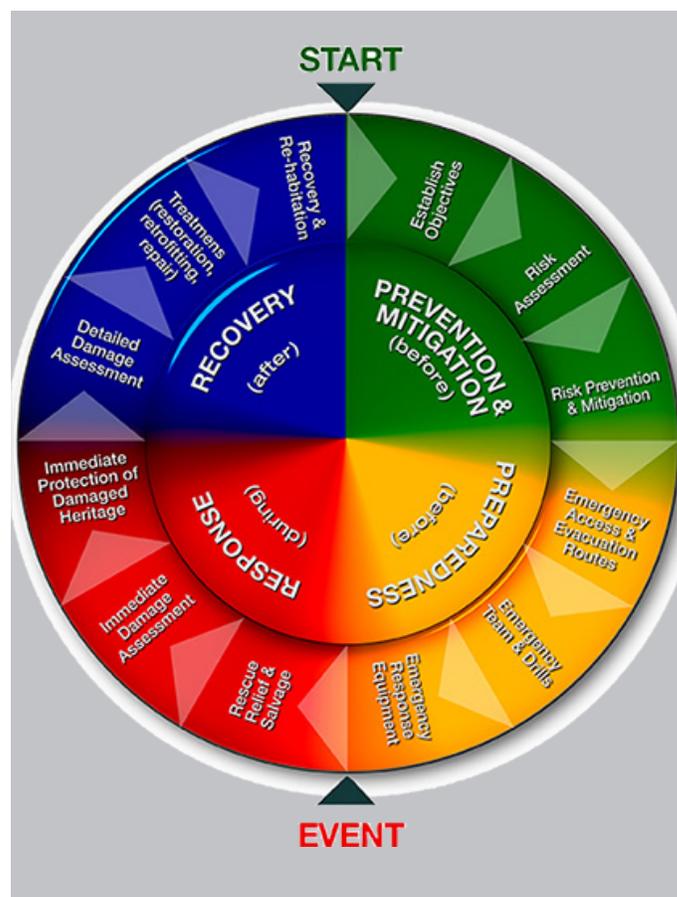
When smoke detectors or sprinklers are installed, there are both aesthetic and financial considerations. So as not to conflict with the building's architecture and ornamentation, it is best, if possible, to not install them in highly conspicuous areas such as in the middle of a highly decorated ceiling or on walls adorned with paintings, carvings or other types of decorations. In these cases, a linear beam smoke detector system might be best.
